# Office of the State Court Administrator

Archuleta County Officials  
Chairman of the Board – Clifford Lucero  
District 1 – Commissioner Steve Wadley  
District 3 – Commissioner Michael Whiting  
County Administrator – Bentley Henderson  
449 San Juan St.  
P.O. Box 1507  
Pagosa Springs, CO 81147

Dear Archuleta County Commissioners

**A STUDY TO ASSESS THE SNOW LOAD CAPACITY  
OF THE ARCHULETA COUNTY COURTHOUSE ROOFS**

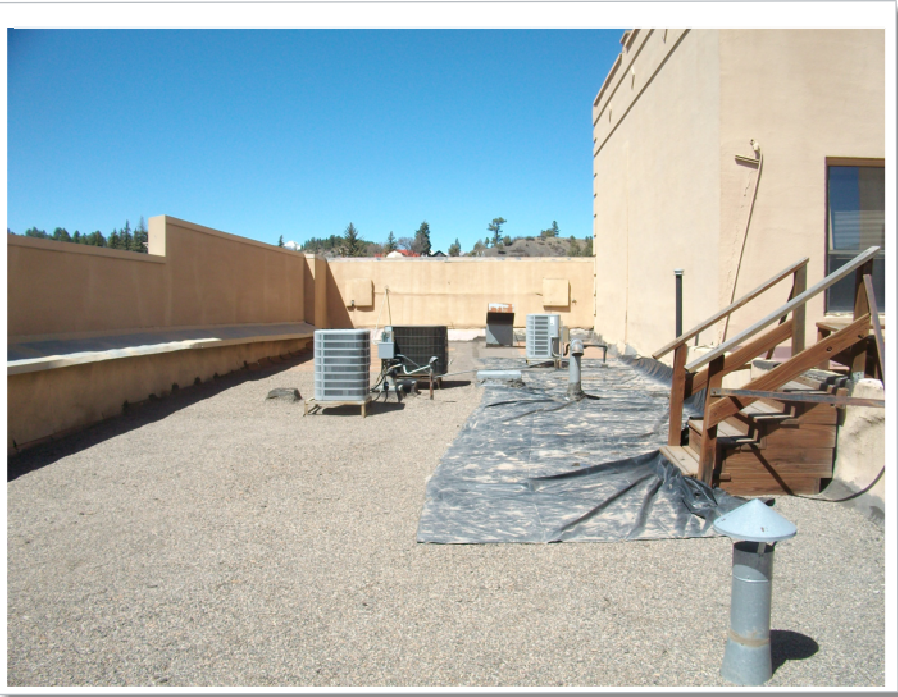
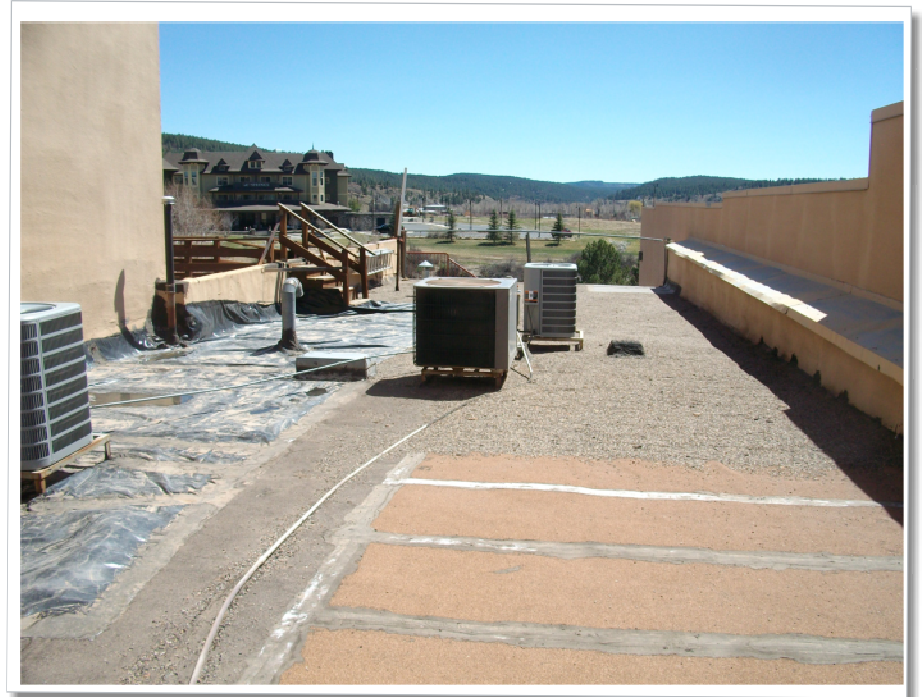
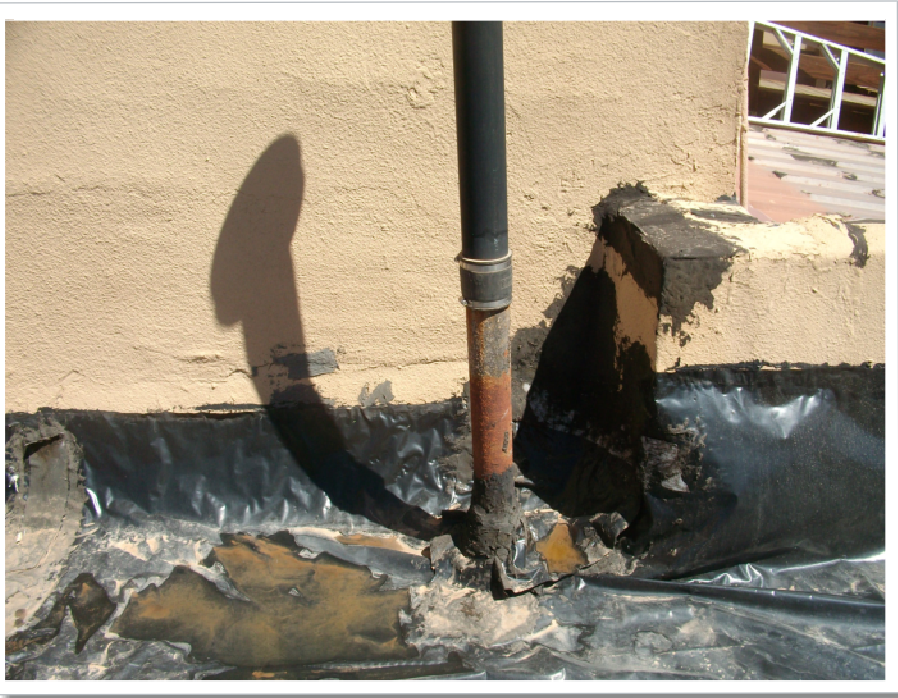
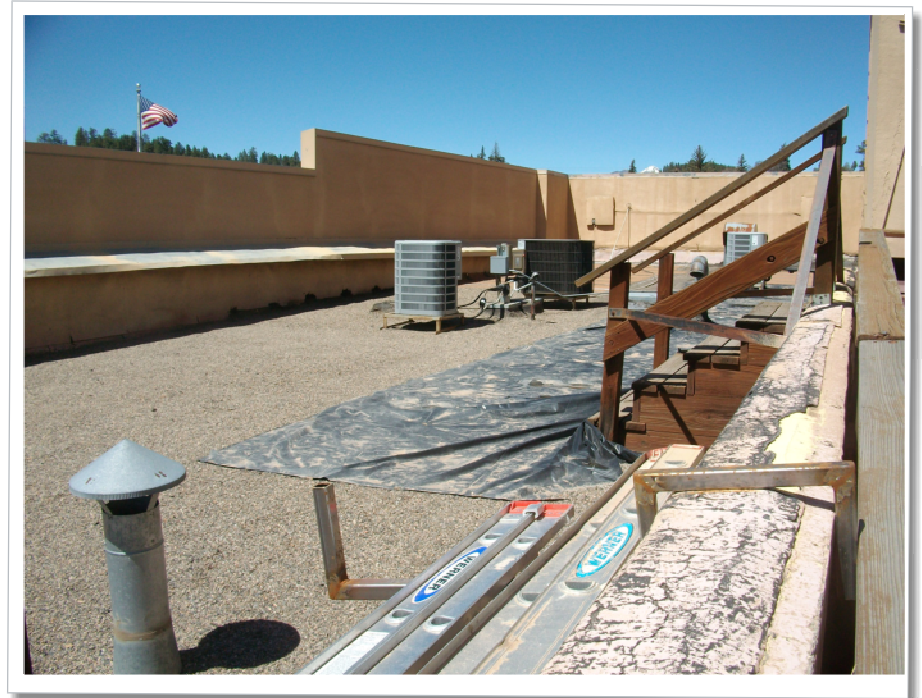
Existing Roof Conditions

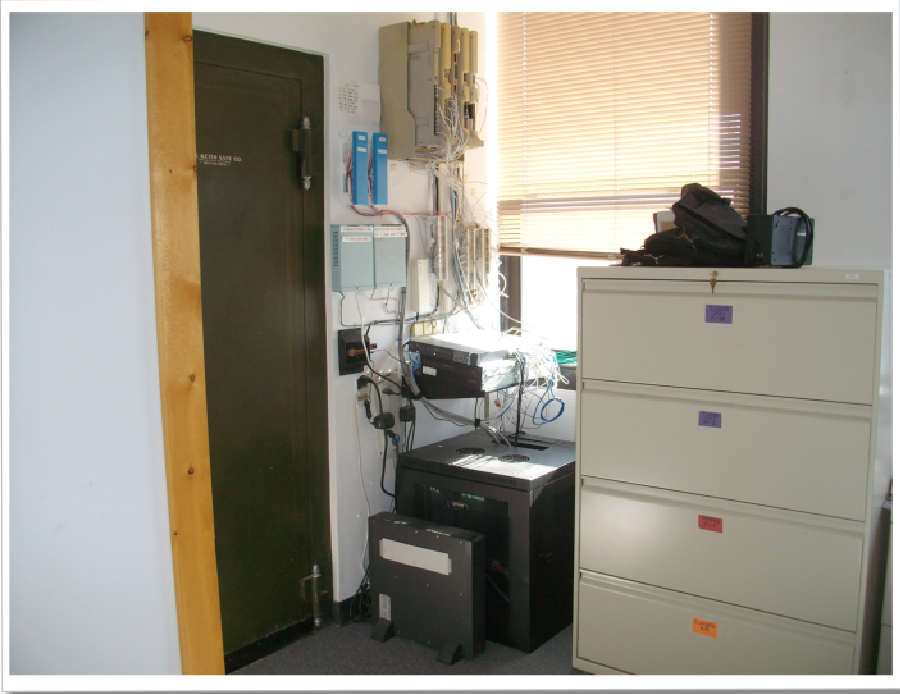
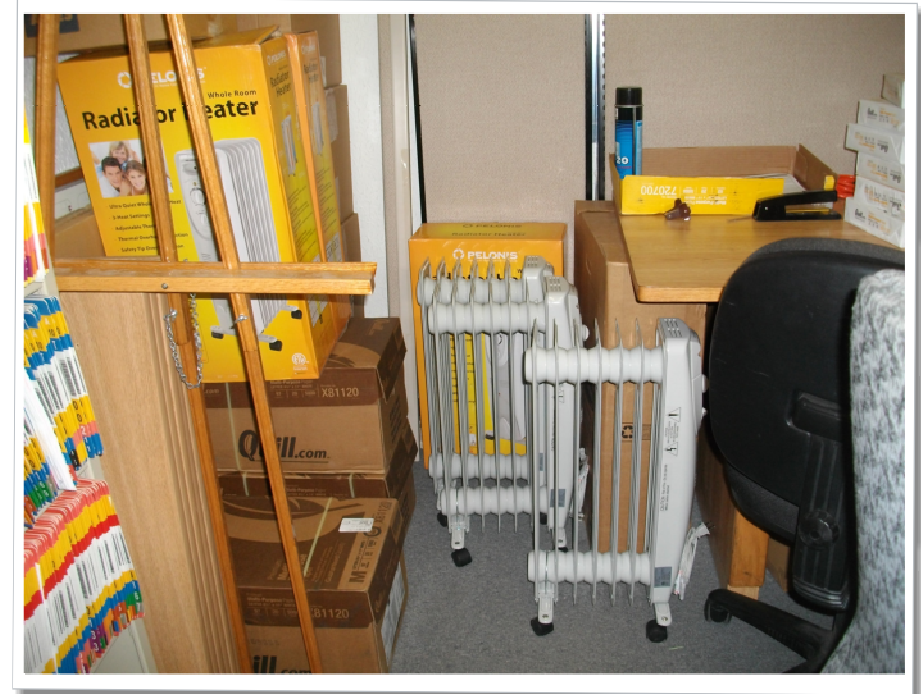
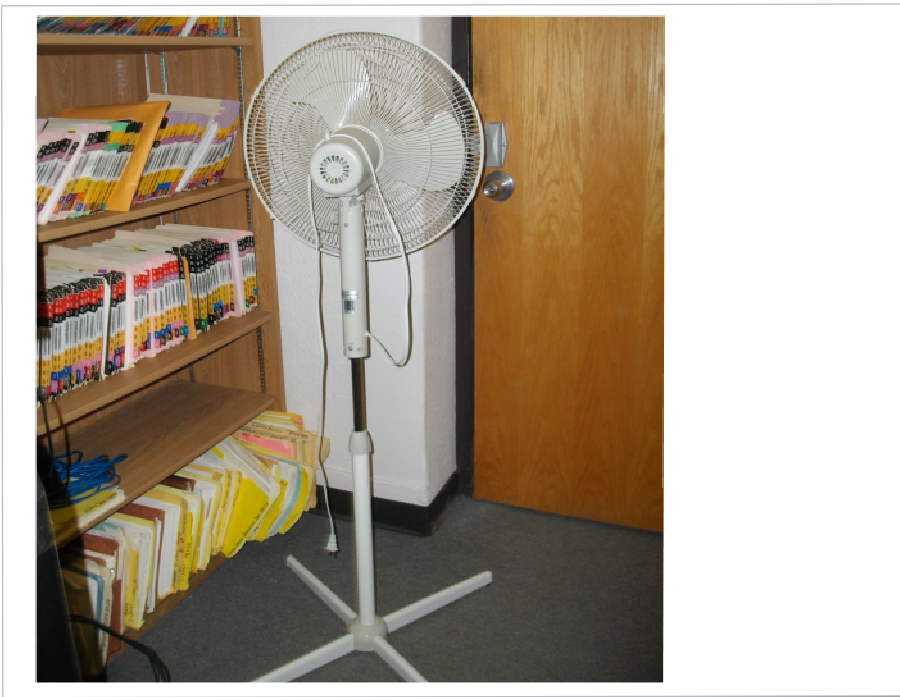
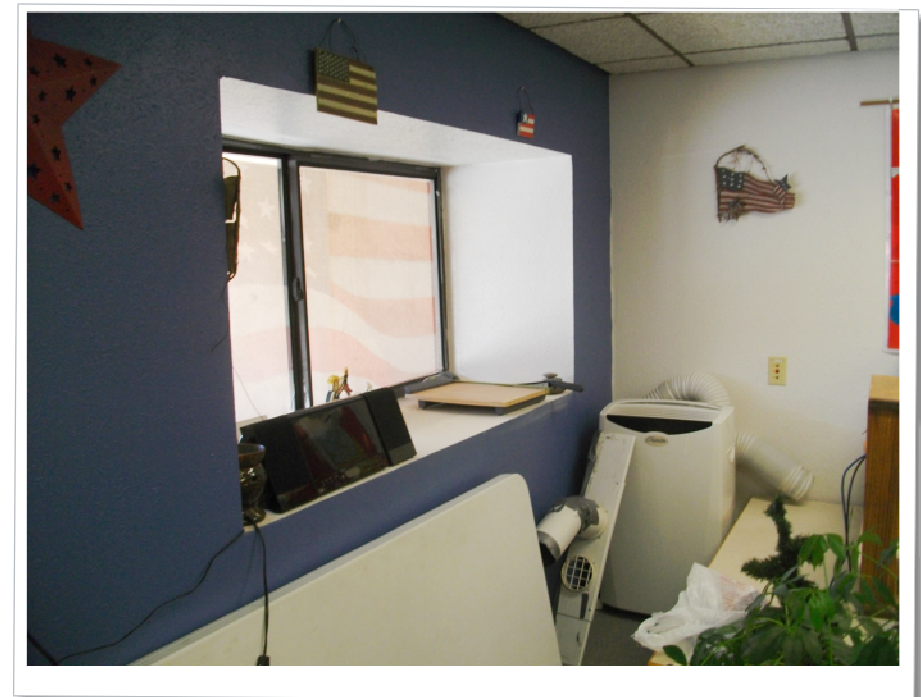
Interior conditions

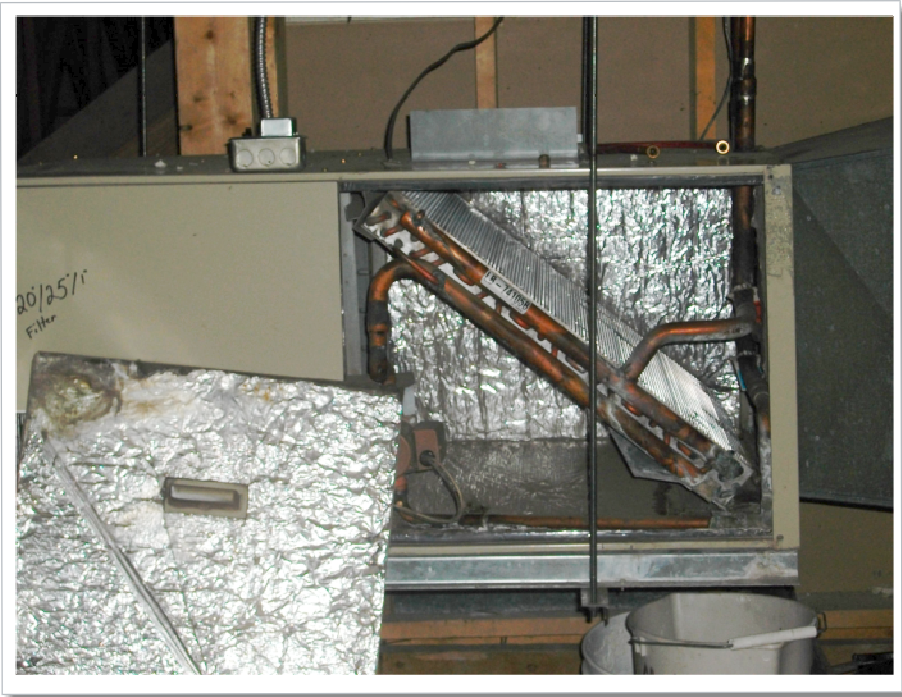
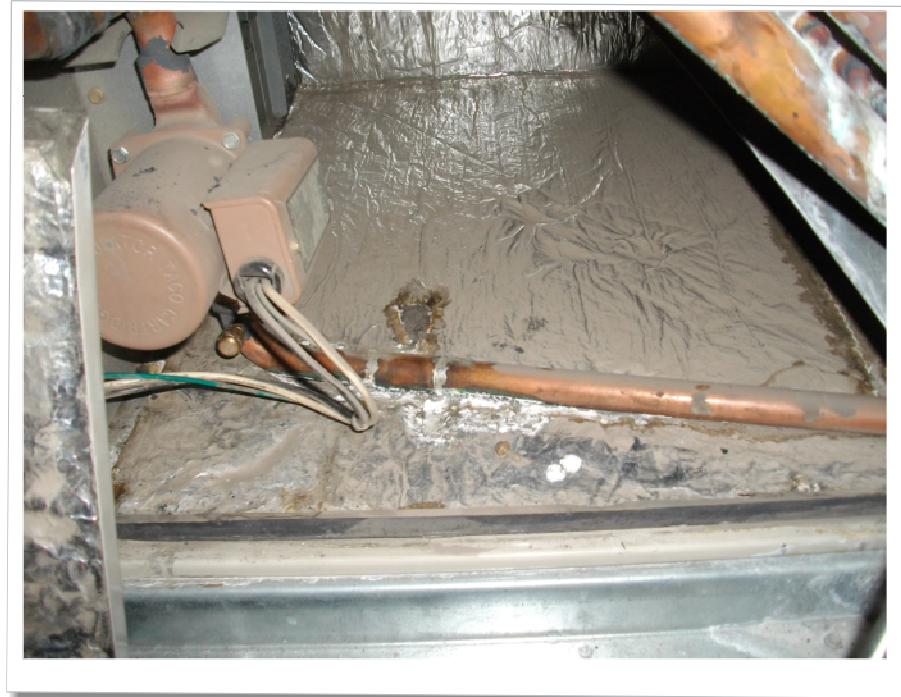
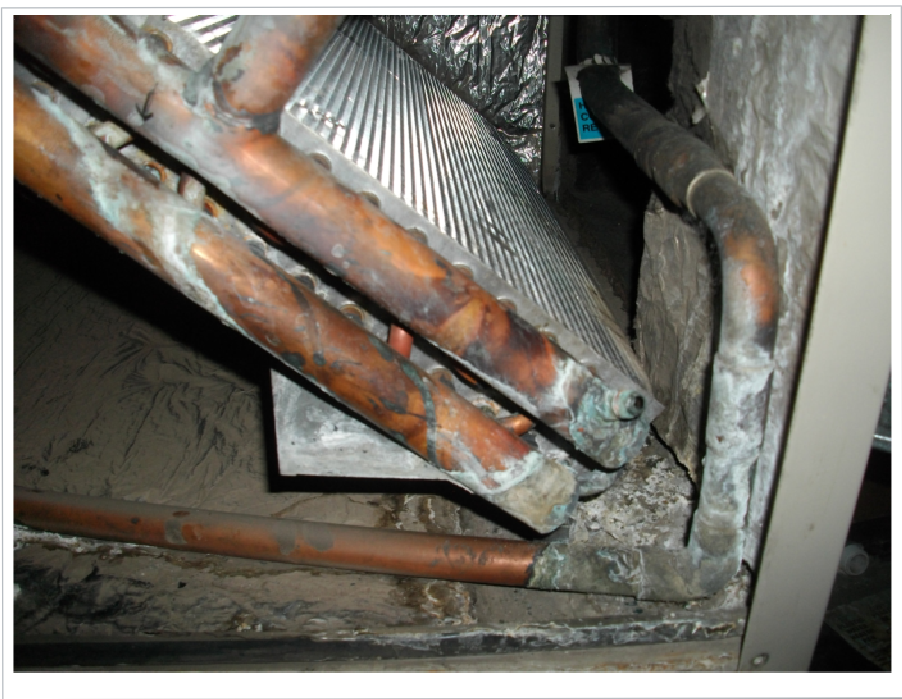
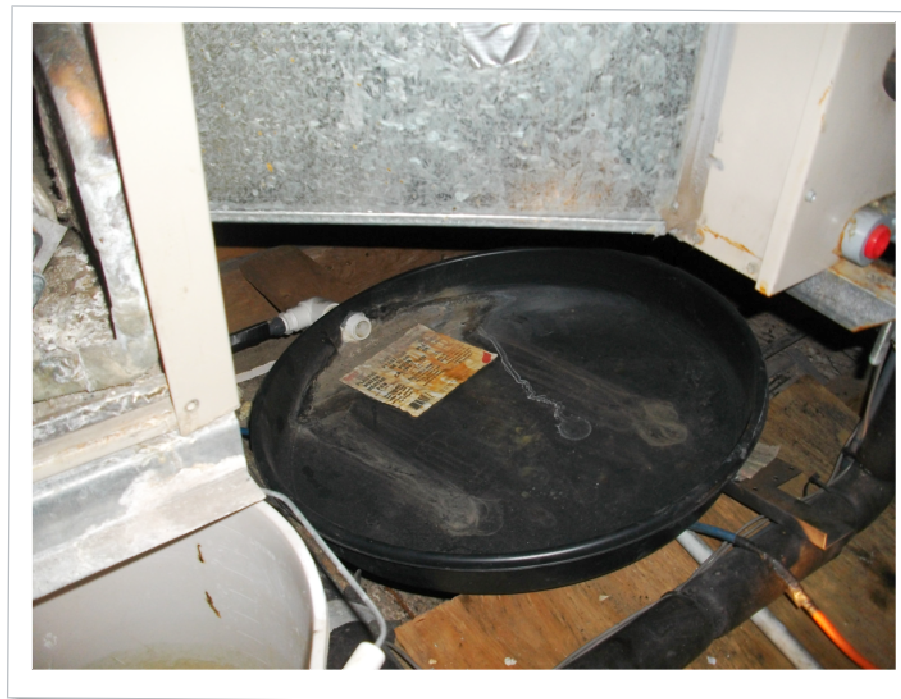
7. The FCU serving the Probation office and one of the FCUs serving the Treasurer's office were not operational. The FCU serving the Probation Office had been taken out of service due to a broken heating coil, however, it was restarted during AGW's April site visit. The heating coil was still broken at the time of the August visit.

FCU serving the Probation Office

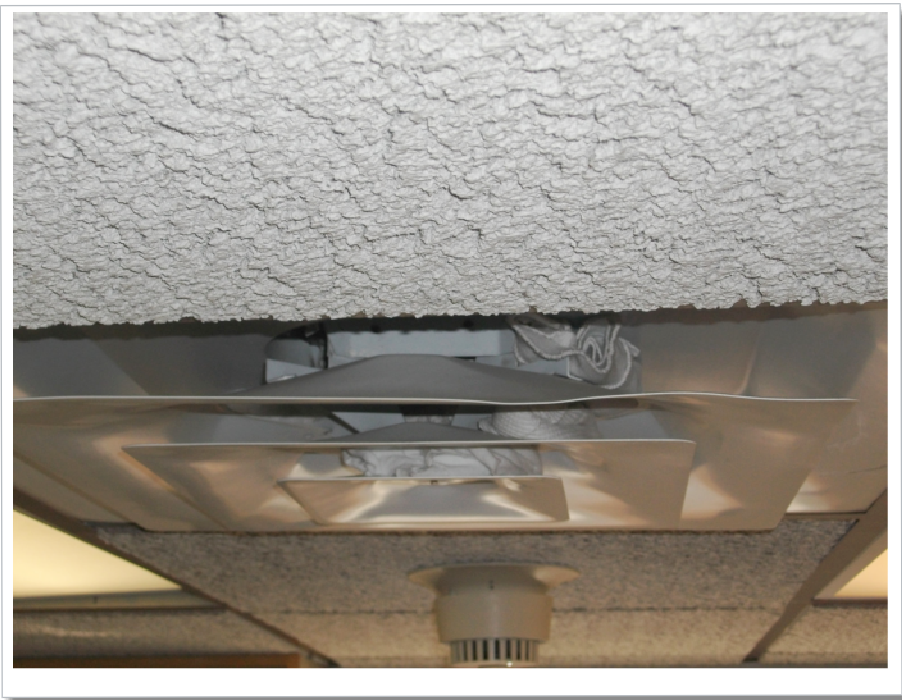
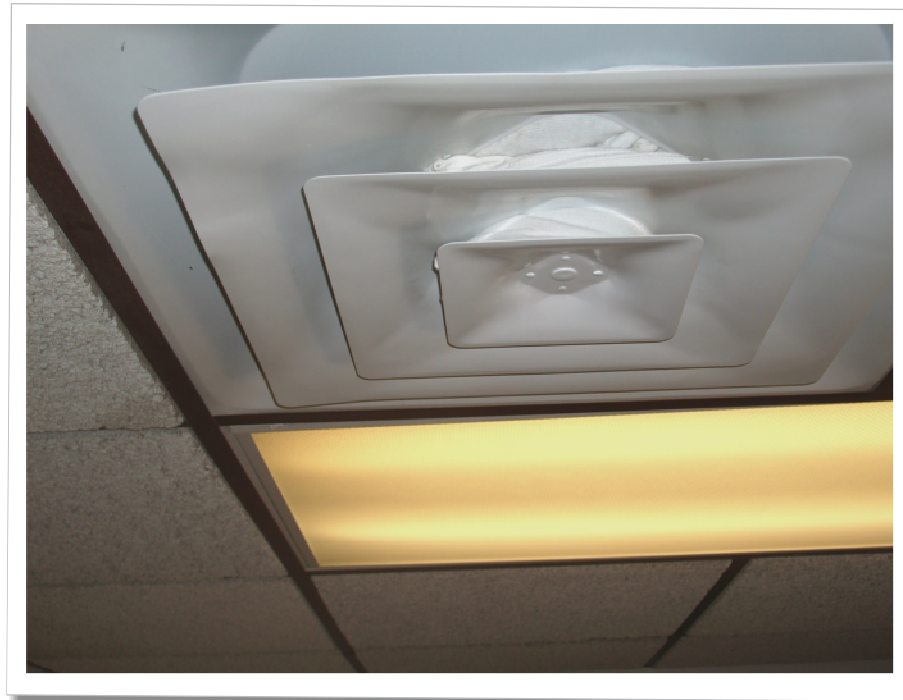
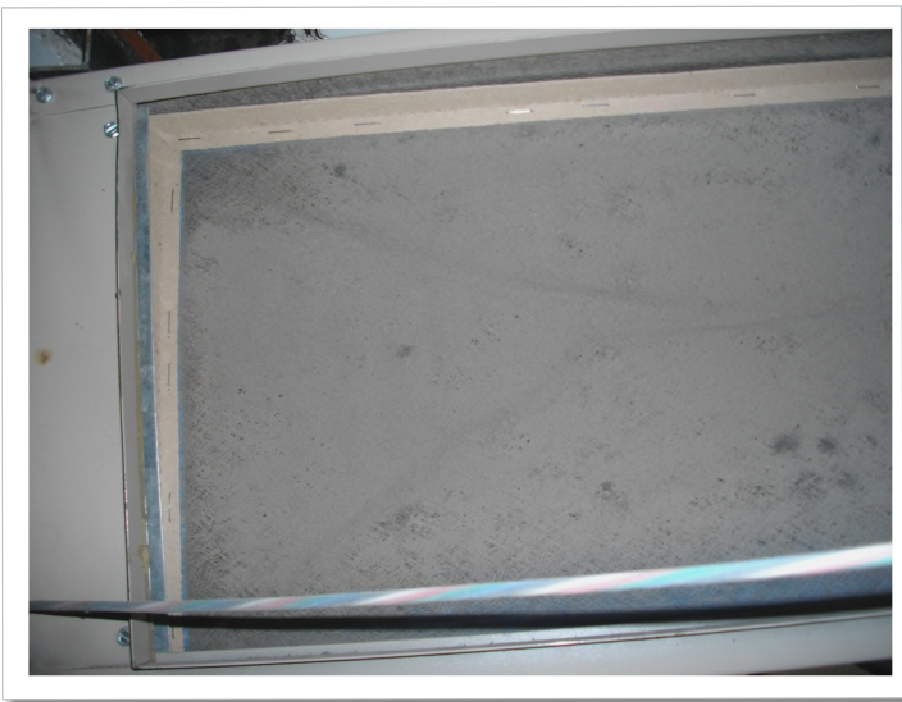
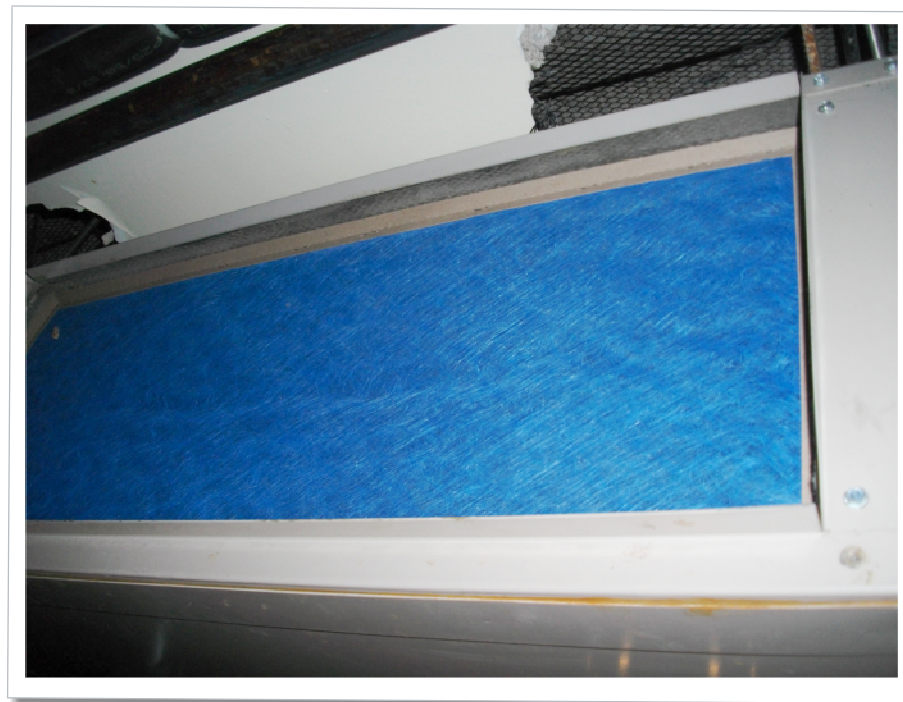
Diffusers with towels in them and FCU filters

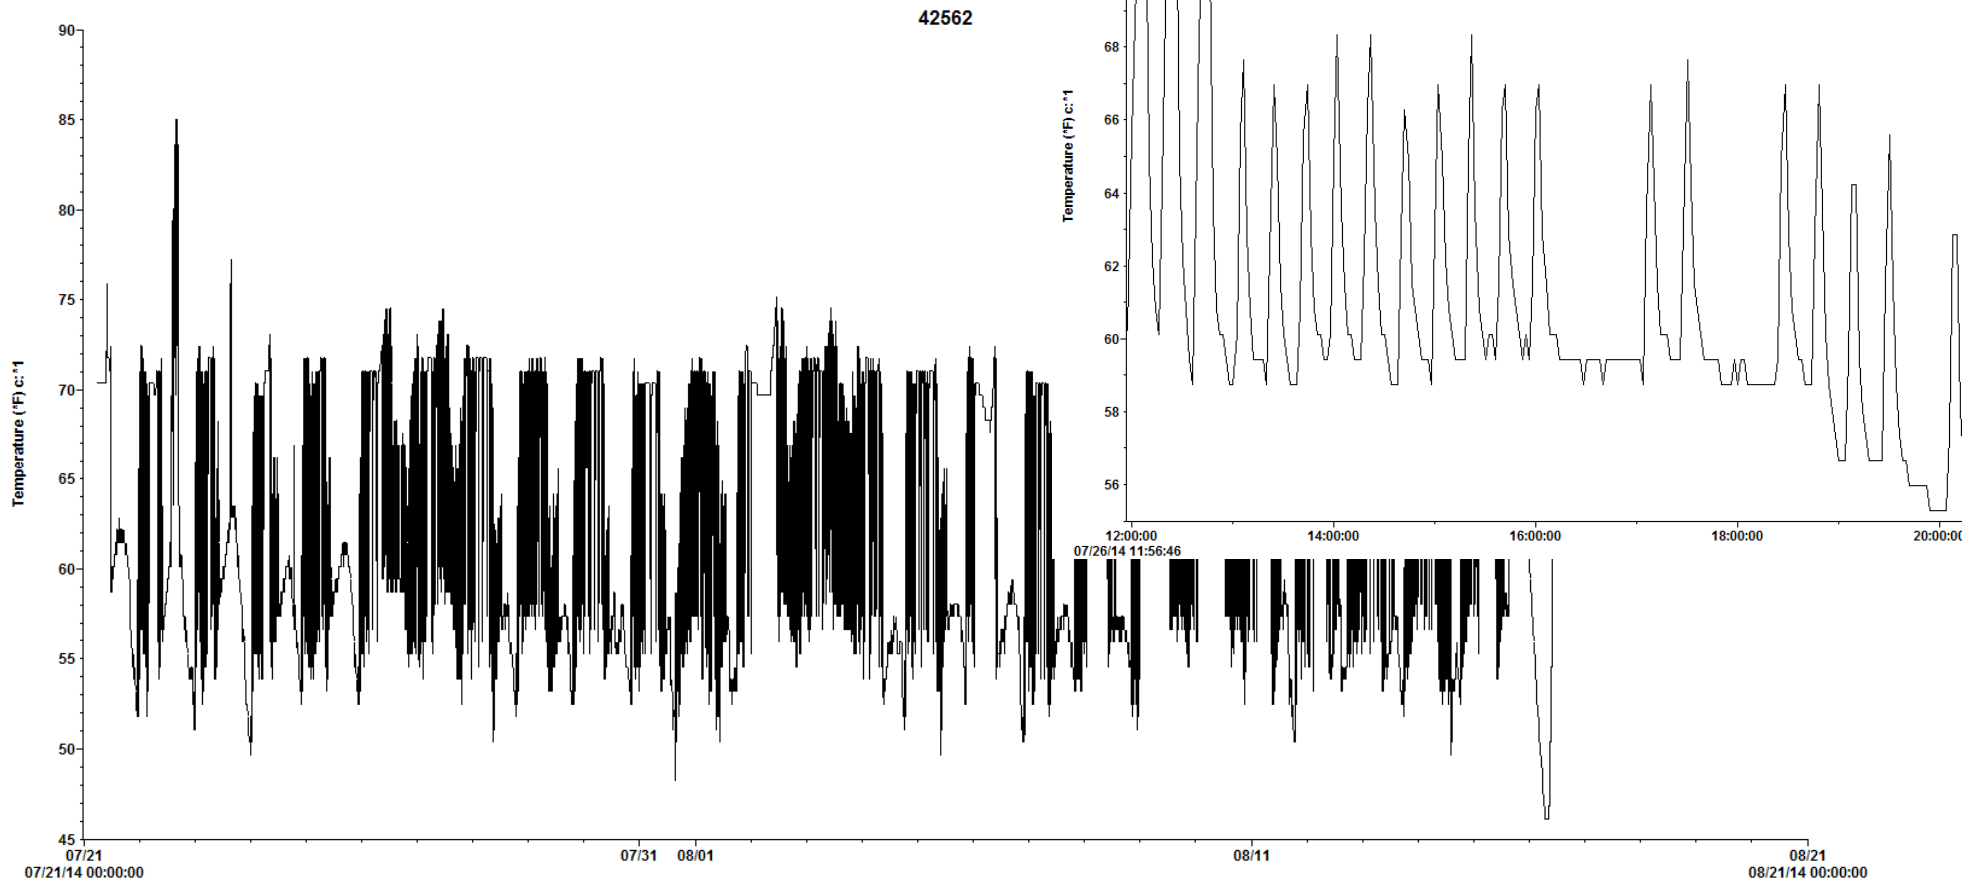
Figure 1: Raw data print out for Ser. No. 42562 (diffuser in County Admin Area). Note temperature fluctuation as associated FCU energizes, then de-energizes associated outdoor cooling condensing unit. INSET: Detail for 12:00 noon to 8:00 pm on July 26<sup>th</sup> (one of the hottest days monitored).
